USACERL Technical Report 98/34  
January 1998

# Seismic Mitigation for Equipment at Army Medical Centers

Methods Illustrated With Examples from Madigan Army Medical Center

by  
James Wilcoski

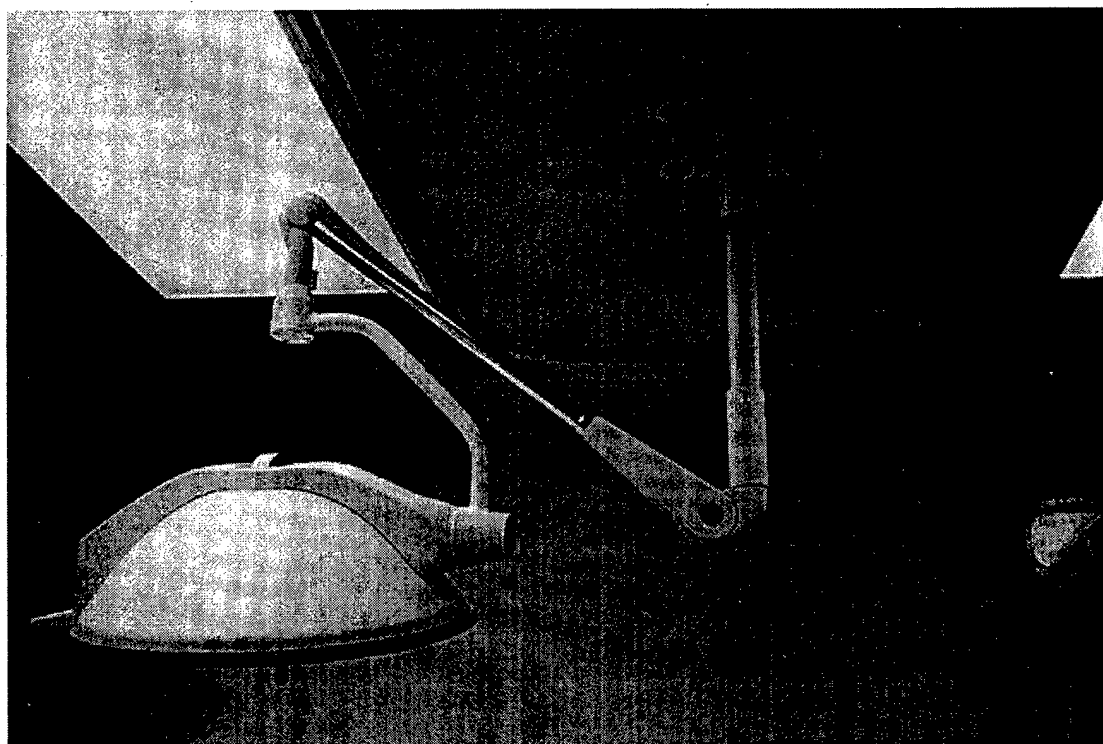
Overhead examination lights such as the one seen in Figure 59 are located throughout MAMC. These are well anchored to the roof above, but the supporting arm appears questionable, especially when fully extended. These may have been seismically qualified, but further investigation is needed to verify that.

**Figure 59. Overhead examination light, typical of those located throughout MAMC.**
